US Army Corps  
of Engineers®  
Engineer Research and  
Development Center

## **Periodic Inspections of Hilo, Kahului, Laupahoehoe, and Nawiliwili Breakwaters, Hawaii**

Armor Unit Monitoring for Period 2001-2005

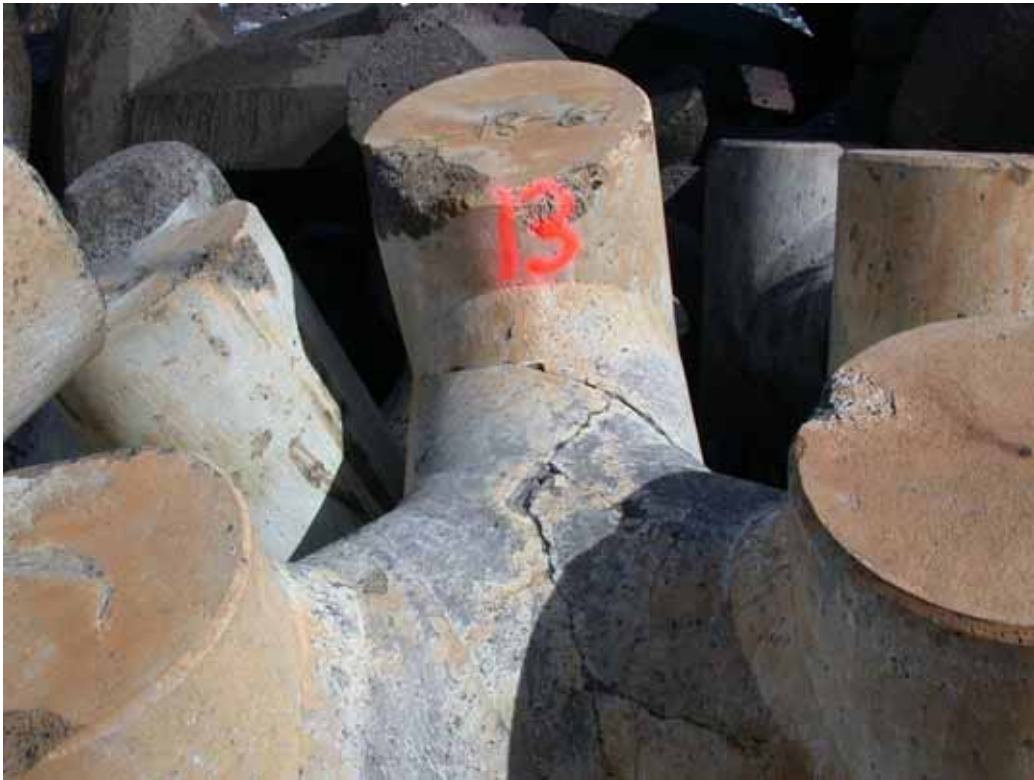
Figure B57. Damage location 19, sta 21+54, ocean side, rib #48, tribar with multiple cracks through center.

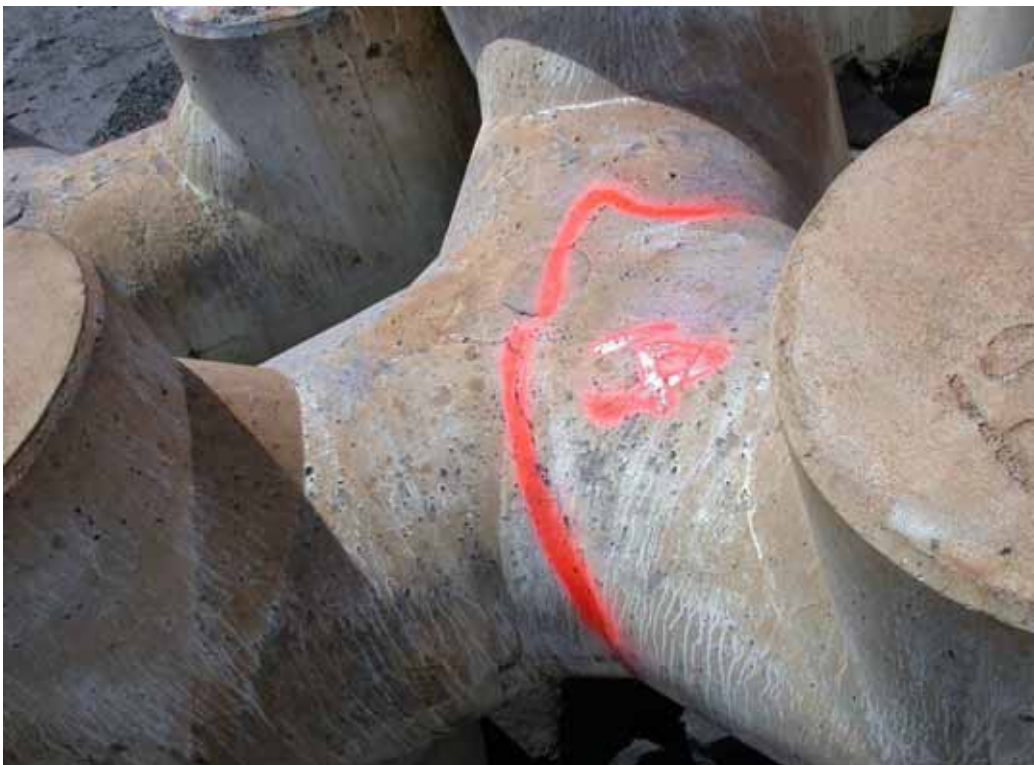
Figure B58. Damage location 20, sta 21+54 – 21+60, ocean side, rib #48-49, tribar with cracks through center.

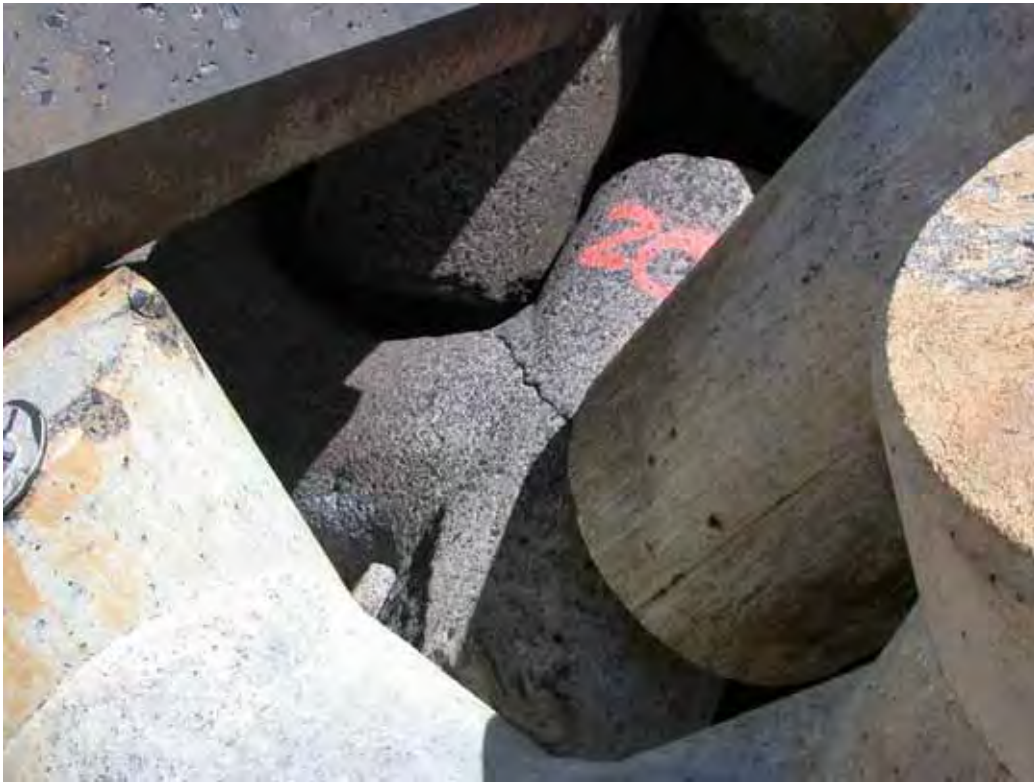
Figure B63. Damage location 26, sta 22+10, ocean side, tribar with crack held together by rebar.

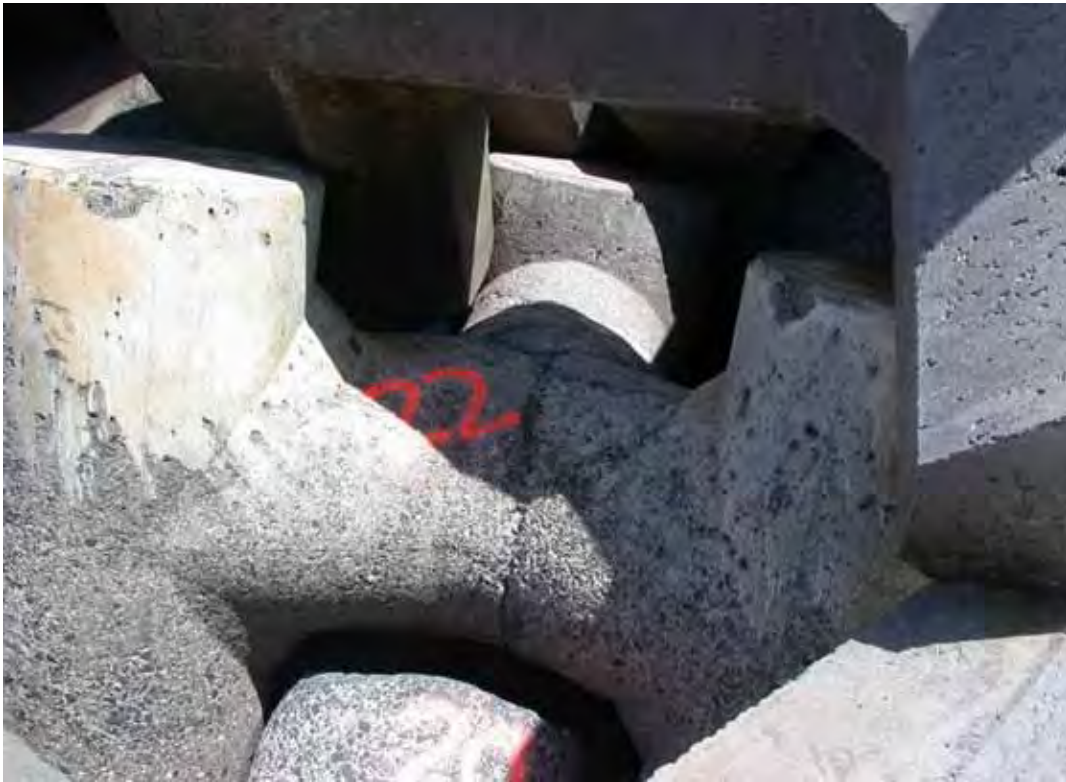
Figure B65. Damage location 28, sta 22+14, ocean side, tribar with broken can held together by rebar.

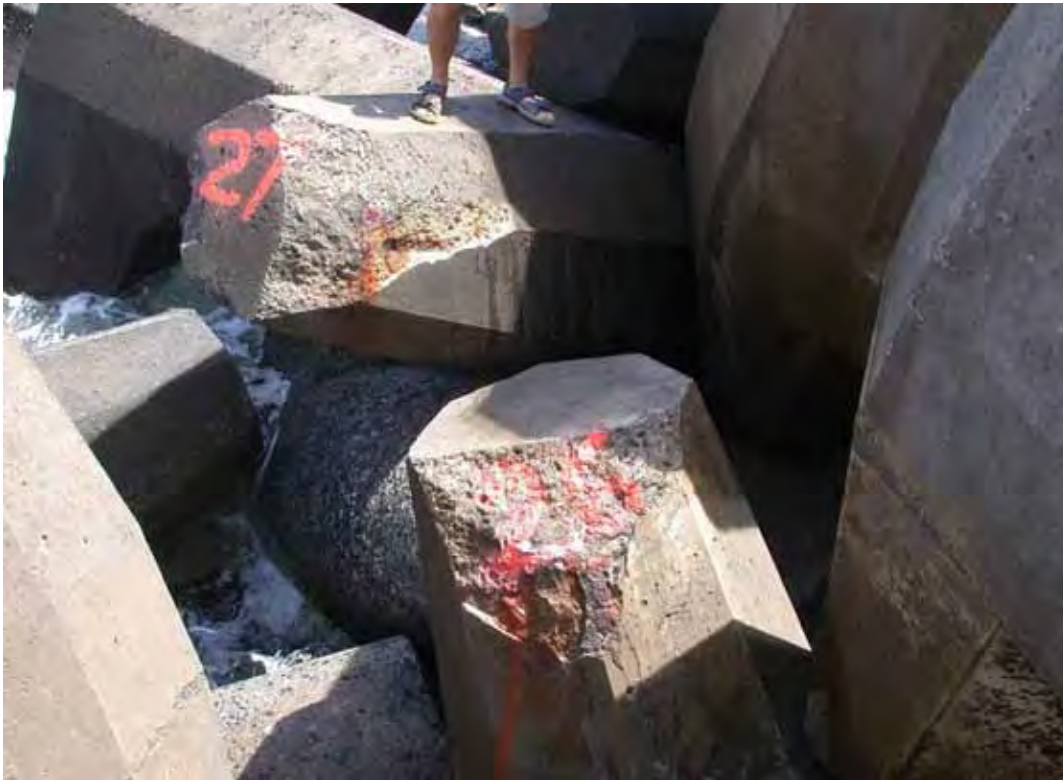
Figure B69. Damage locations 33 & 34, sta 22+35, ocean side, two dolosse with fluke tip breaks.

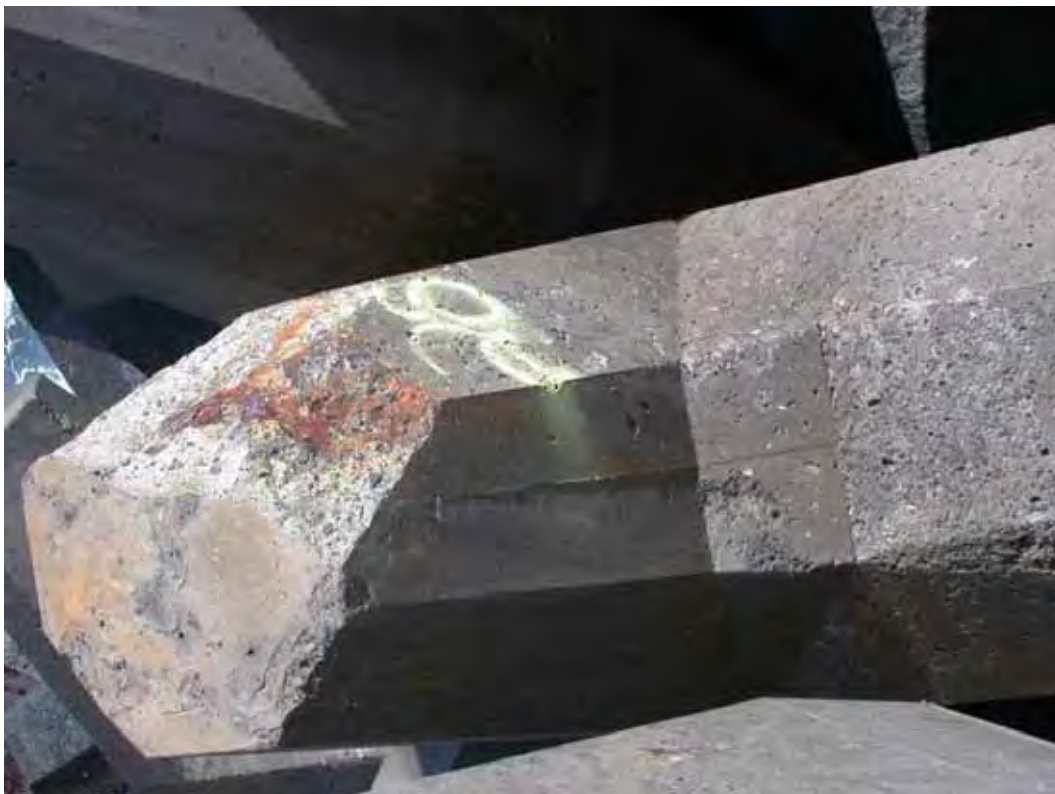
Figure B70. Damage location 35, sta 22+38, ocean side, dolosse with tip break.

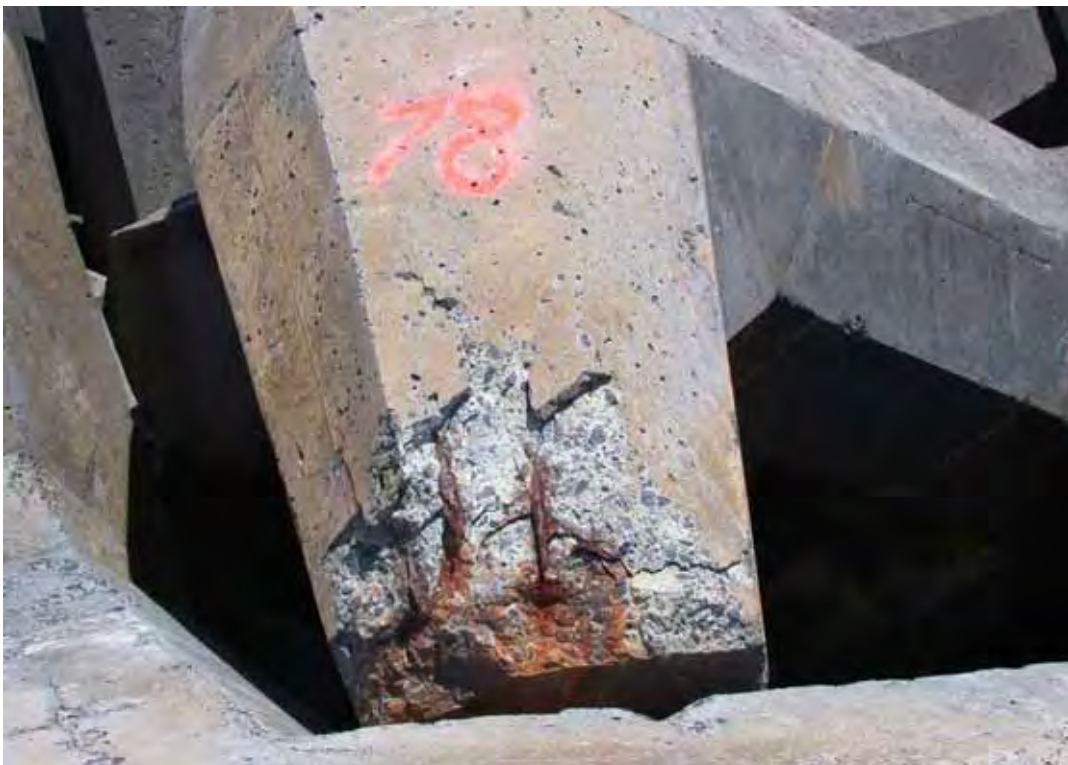
Figure B74. Damage location 40, sta 22+70, ocean side, dolosse with spalling and exposed rebar on fluke tip.

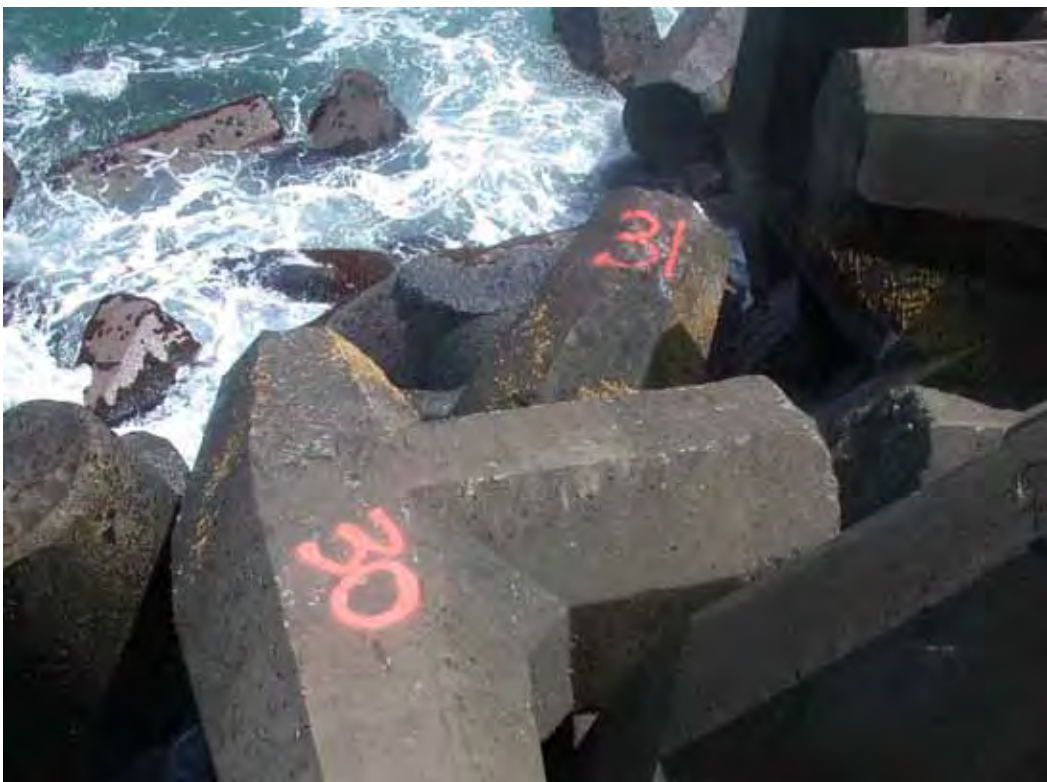
Figure B76. Damage locations 42 & 43, sta 22+74, ocean side, two dolosse with shank-fluke breaks.

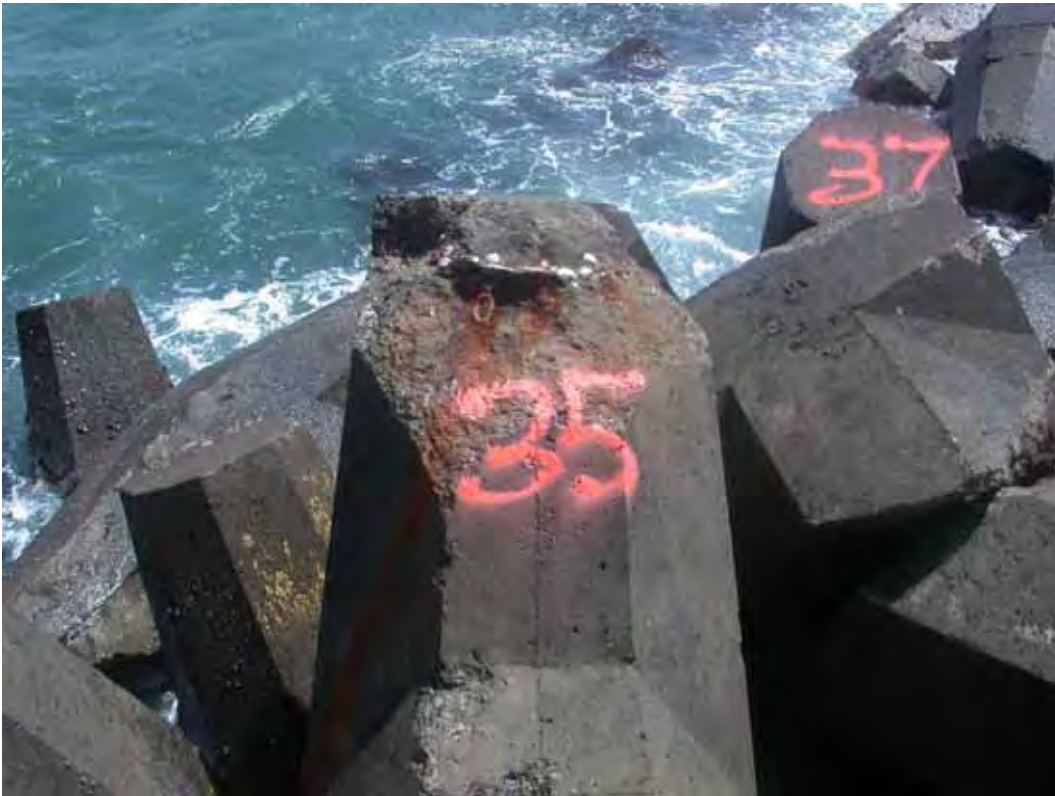
Figure B77. Damage location 46, sta 22+88, ocean side, dolosse with fluke tip break.

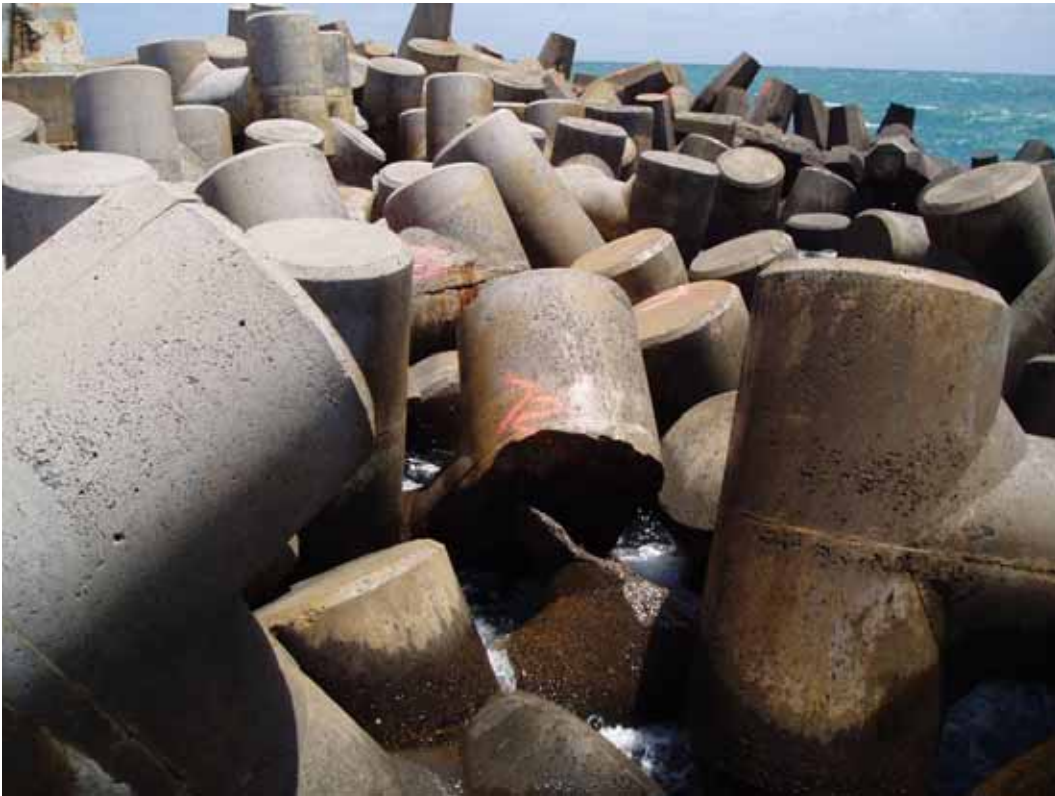
Figure B79. Damage location 48, sta 22+90, harbor side, tribar with broken can.

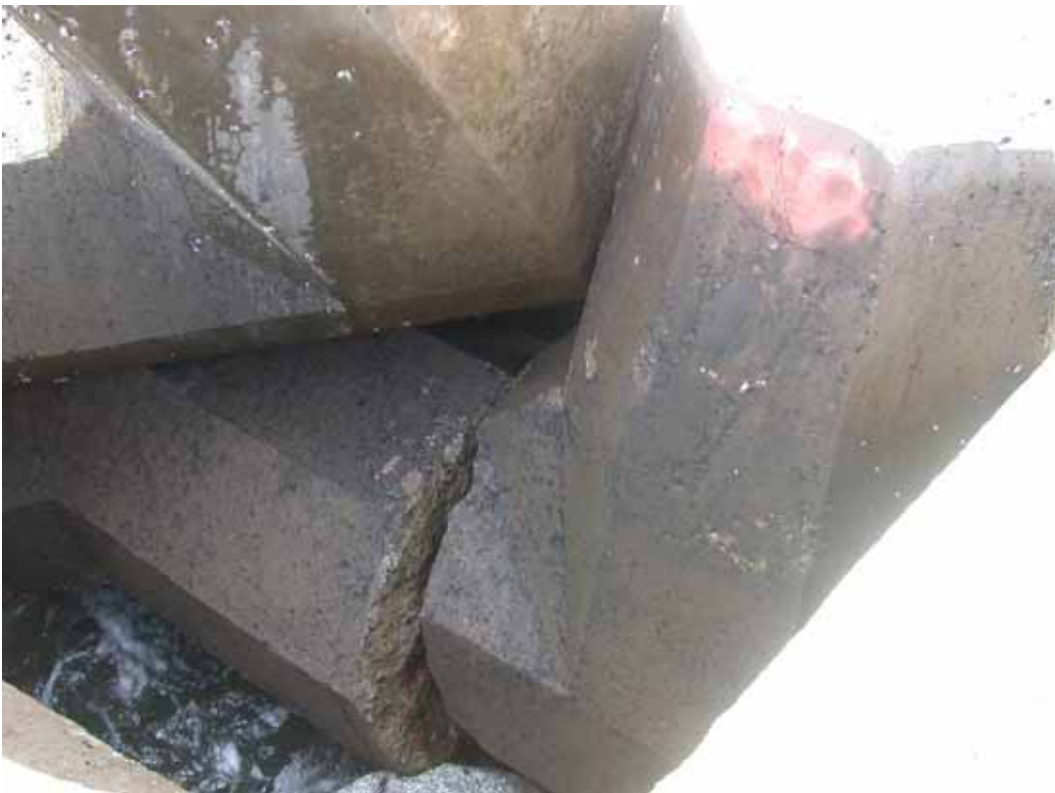
Figure B80. Damage location 49, sta 22+92, ocean side, dolosse with shank-fluke break.

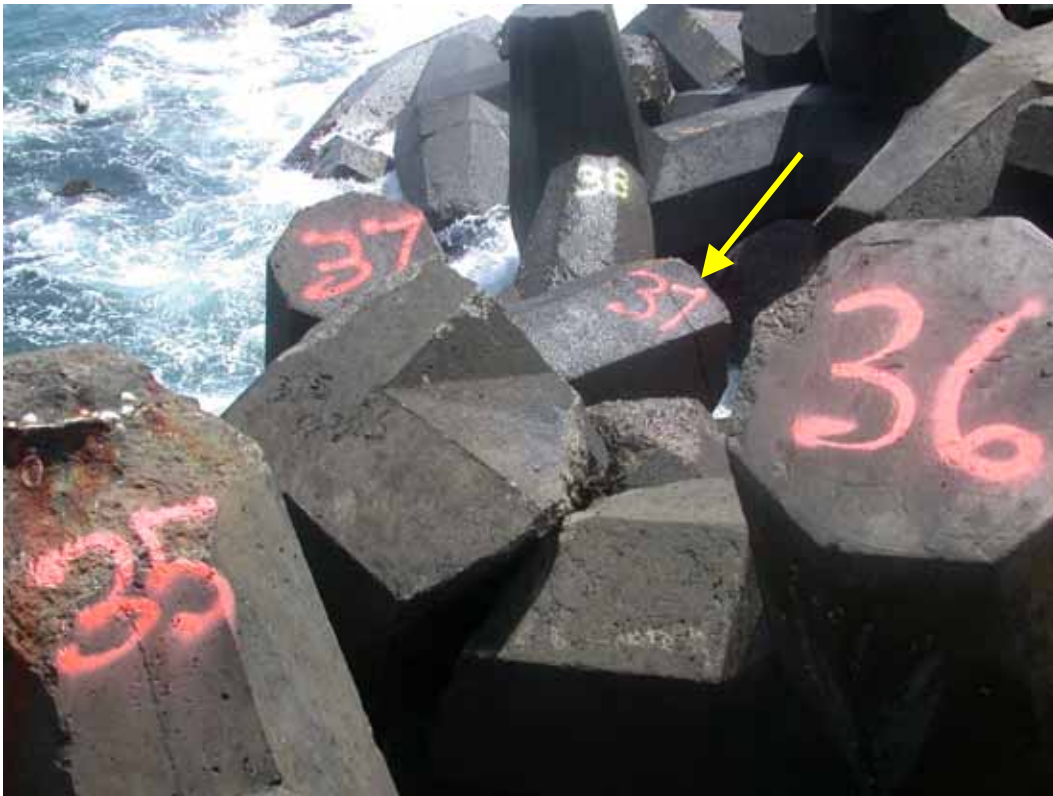
Figure B81. Damage location 50, sta 22+94, ocean side, dolosse with mid shank break.

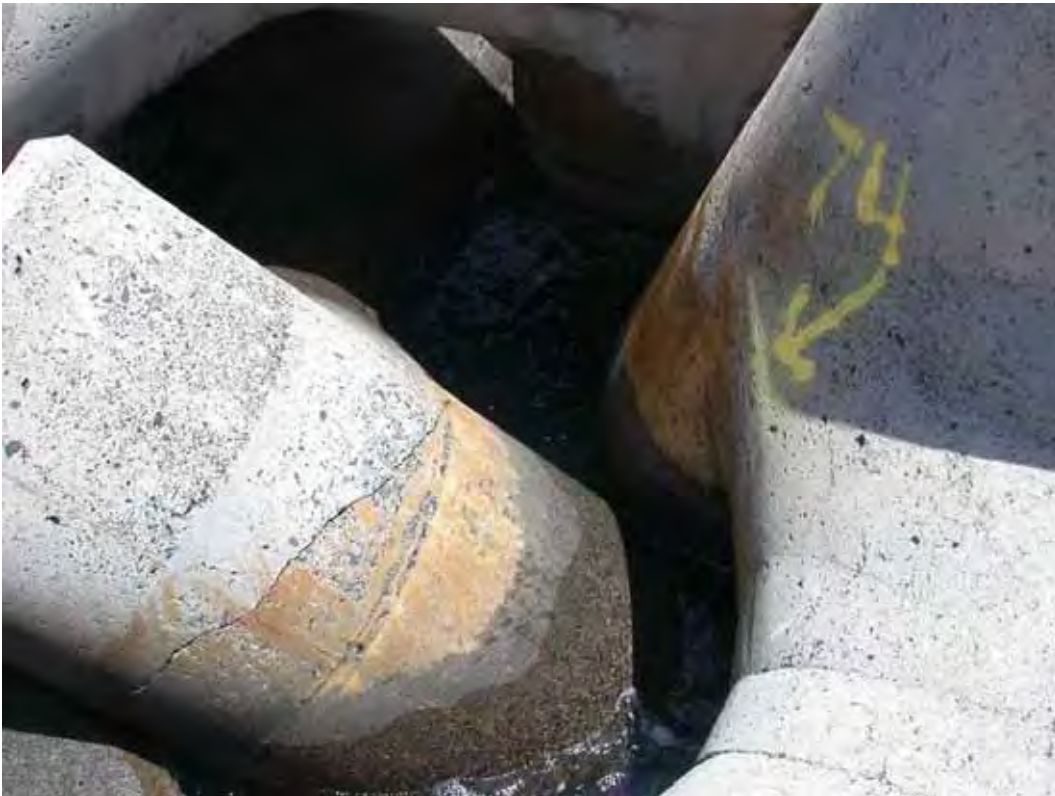
Figure B83. Damage location 52, sta 22+98, harbor side, cracked tribar.

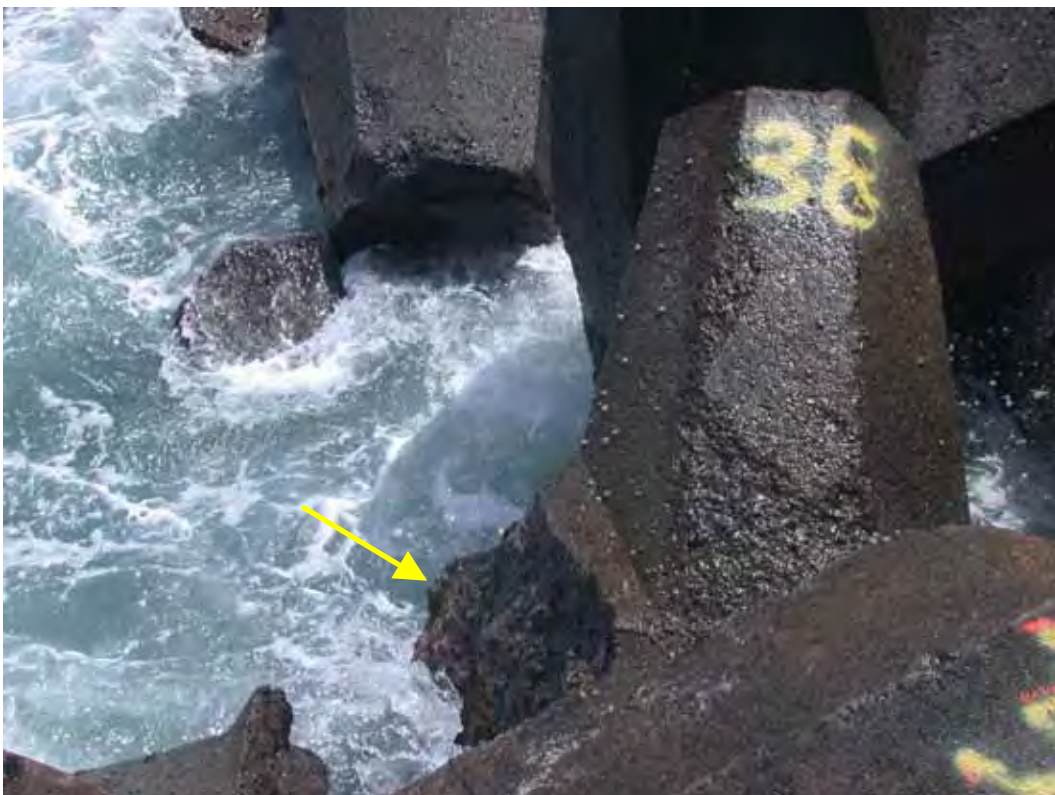
Figure B84. Damage location 53, sta 23+00, ocean side, dolosse with shank-fluke break.

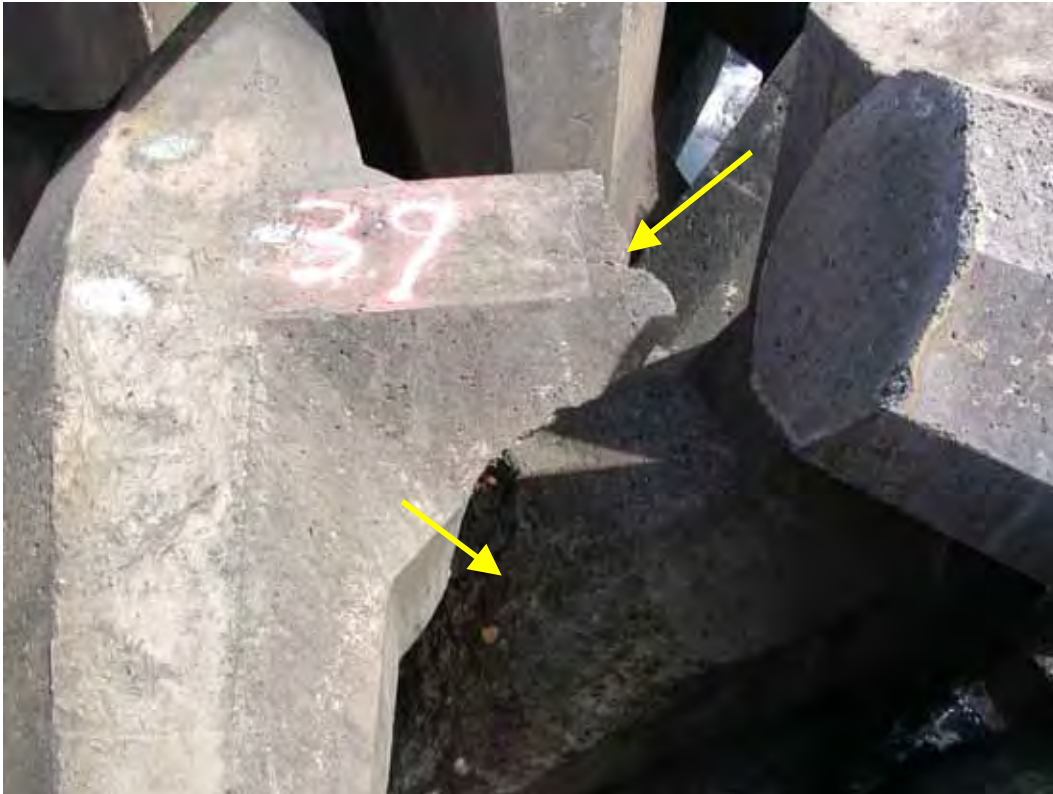
Figure B85. Damage location 54, sta 23+05, ocean side, dolosse with mid shank break.

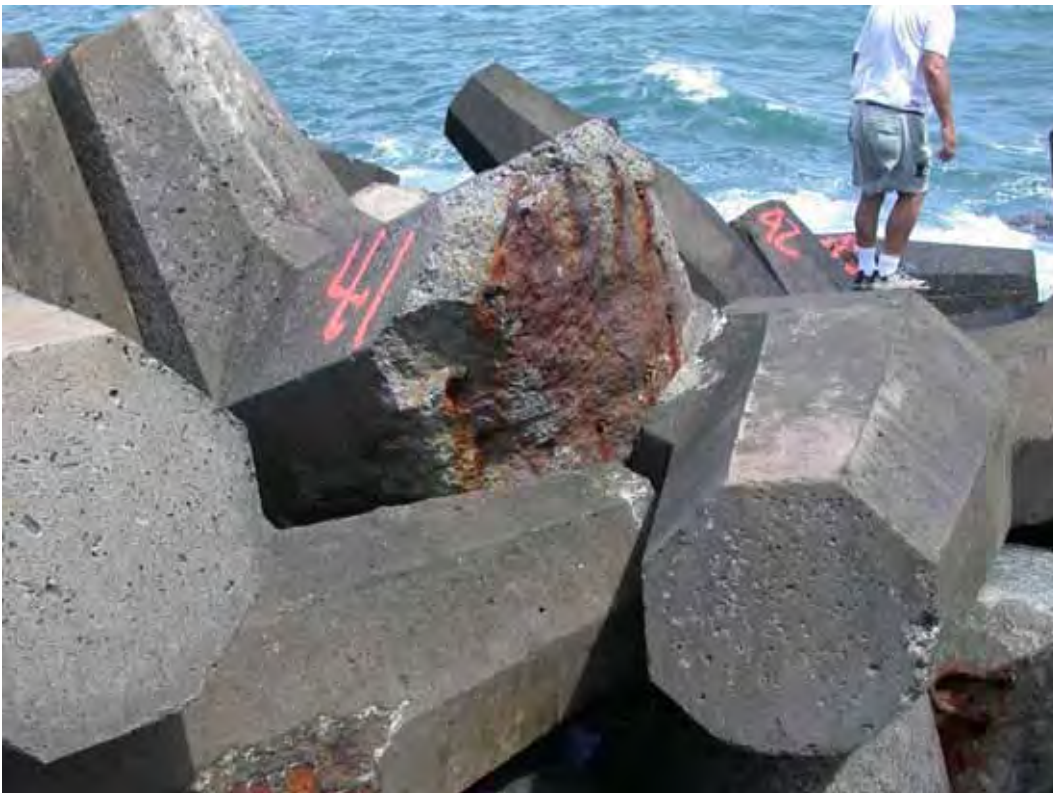
Figure B86. Damage location 55, sta 23+19, ocean side, dolosse with shank-fluke break.

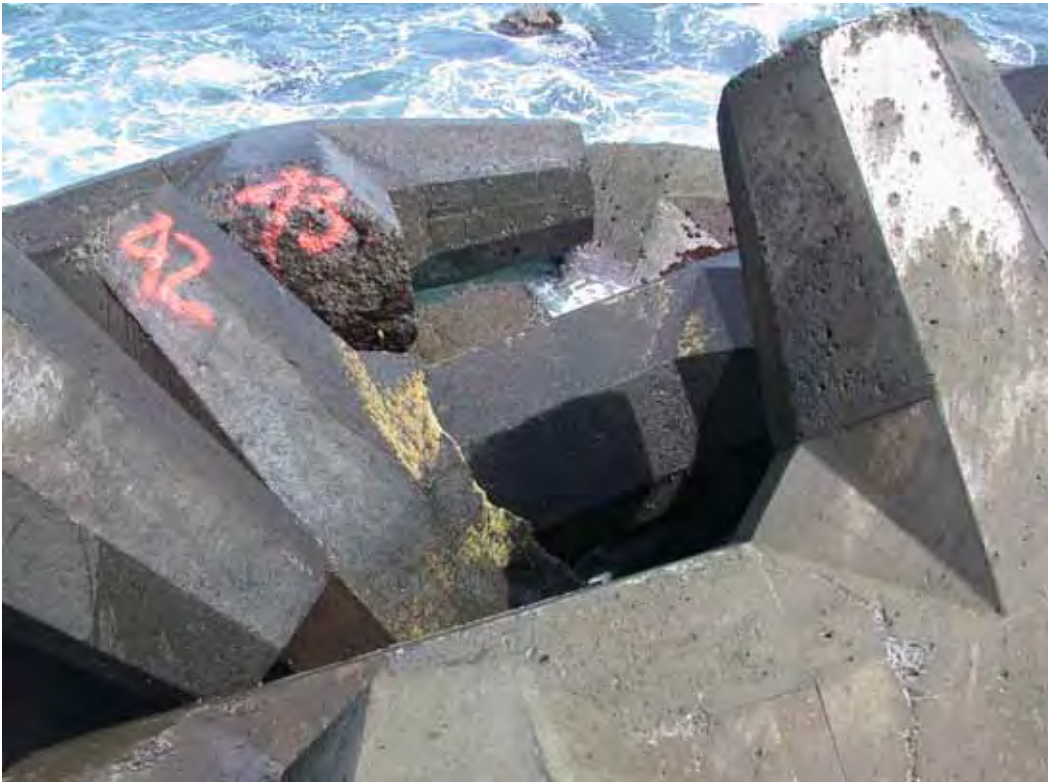
Figure B87. Damage locations 56 & 57, sta 23+19, ocean side, two dolosse with shank-fluke breaks.

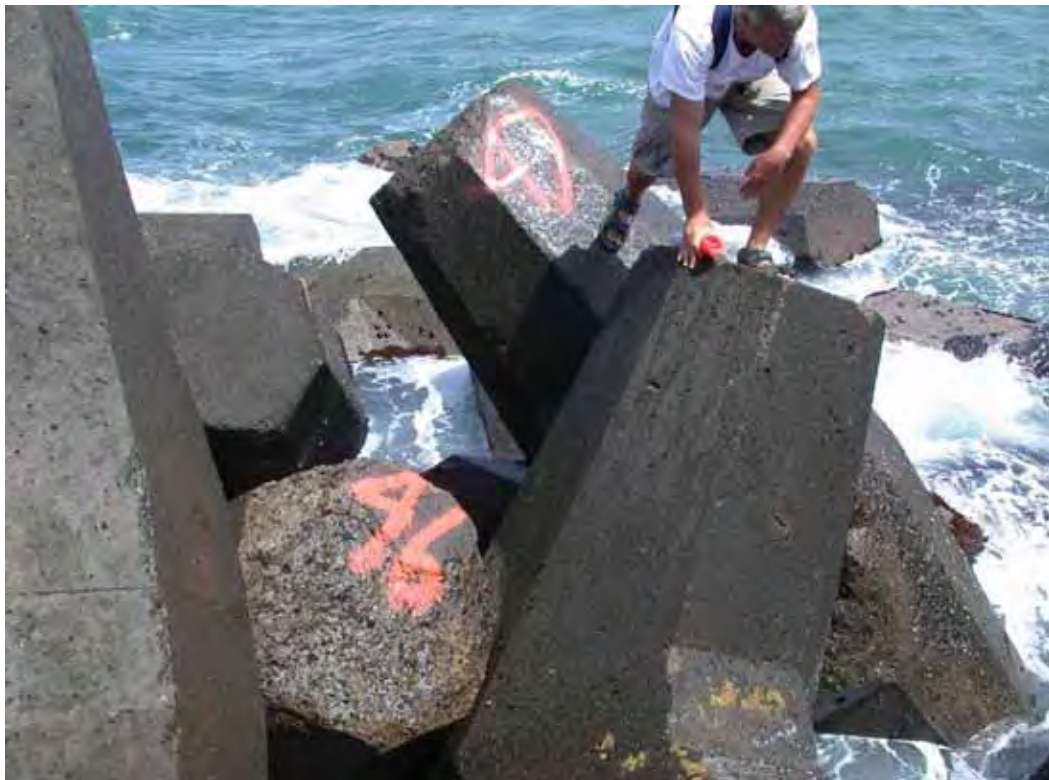
Figure B90. Damage locations 60 & 61, sta 23+30, ocean side, dolosse with mid-shank break and dolosse with shank-fluke break.

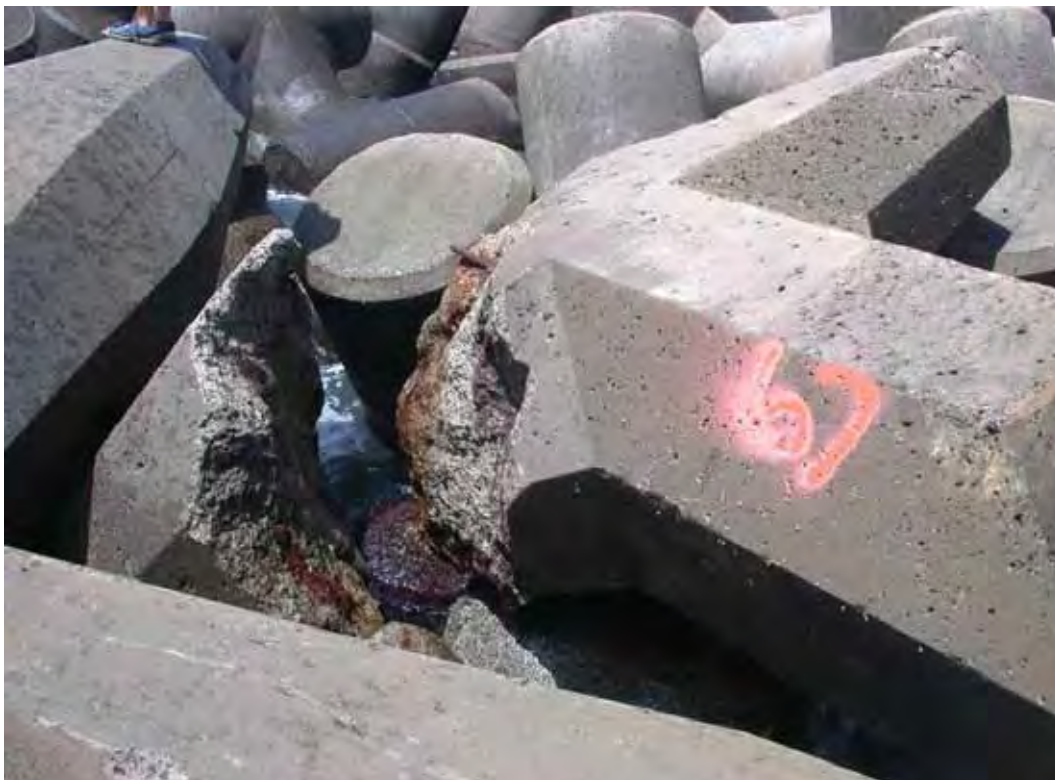
Figure B98. Damage location 81, 15 deg harbor side of head, dolosse with fluke-shank break.

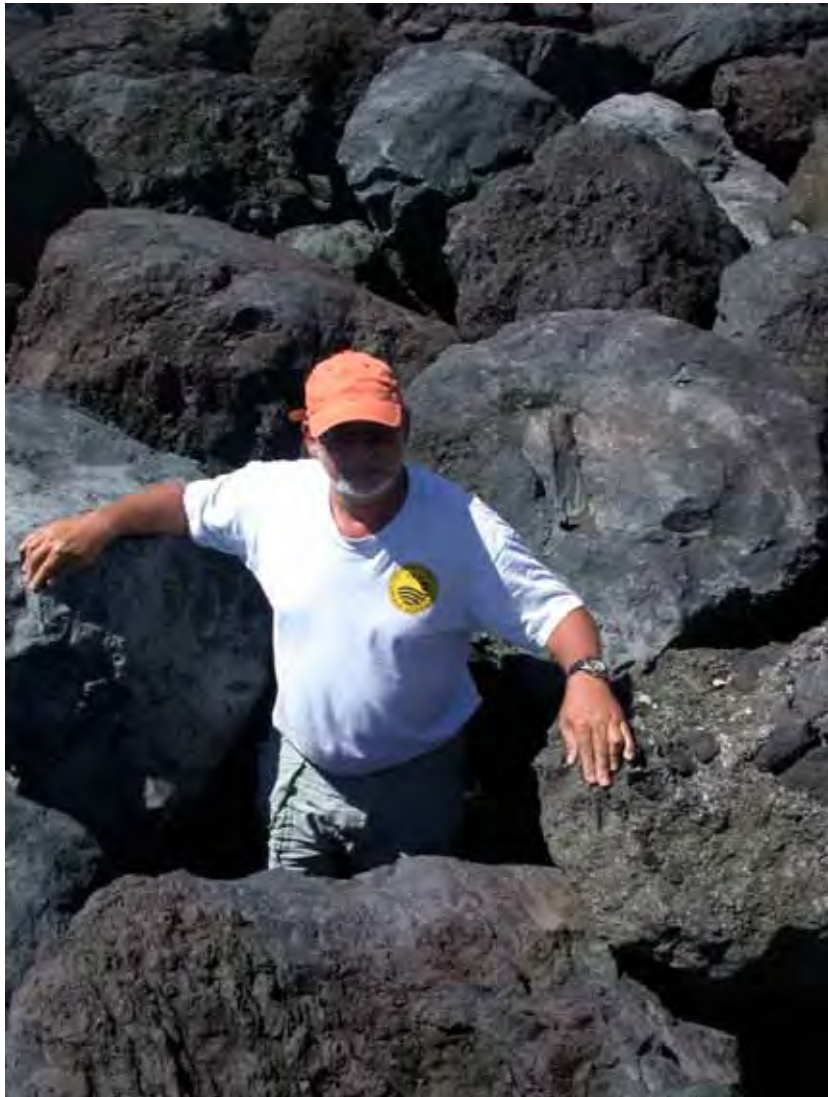
Figure C4. Void.

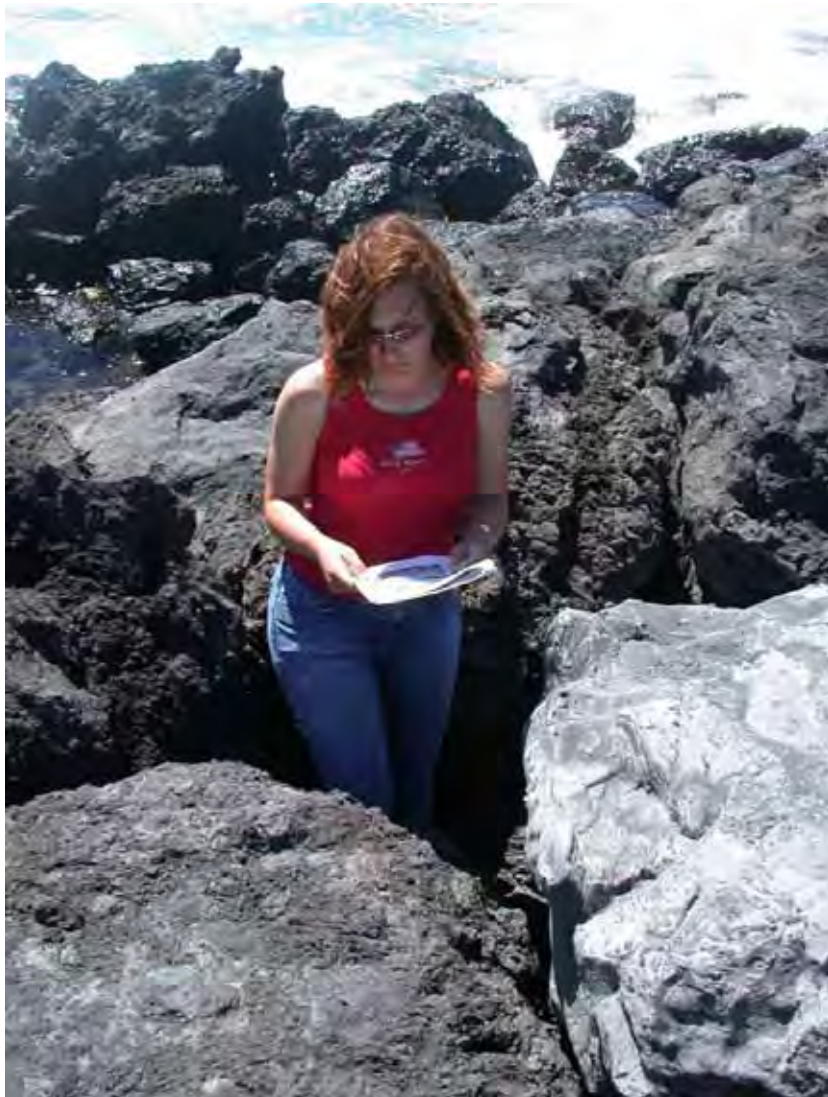
Figure C5. Void.

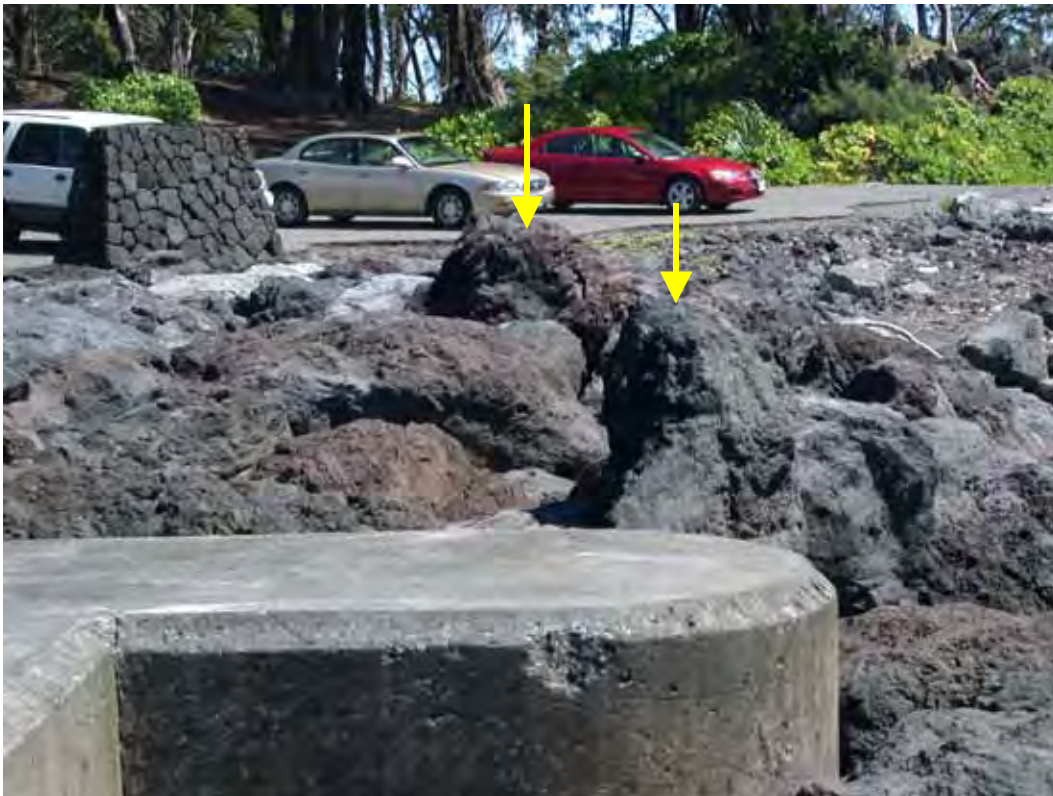
Figure C6. Oceanside, flipped armor stones.

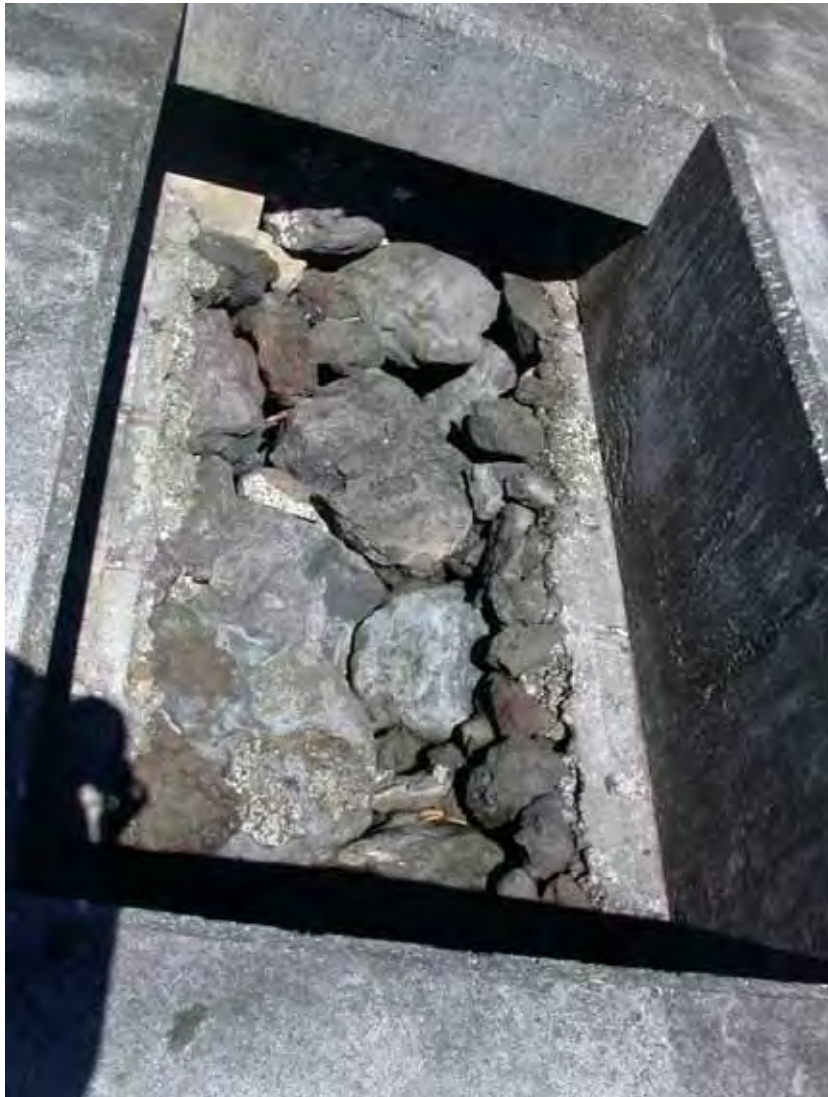
Figure C8. Shifting of stones between ribs.

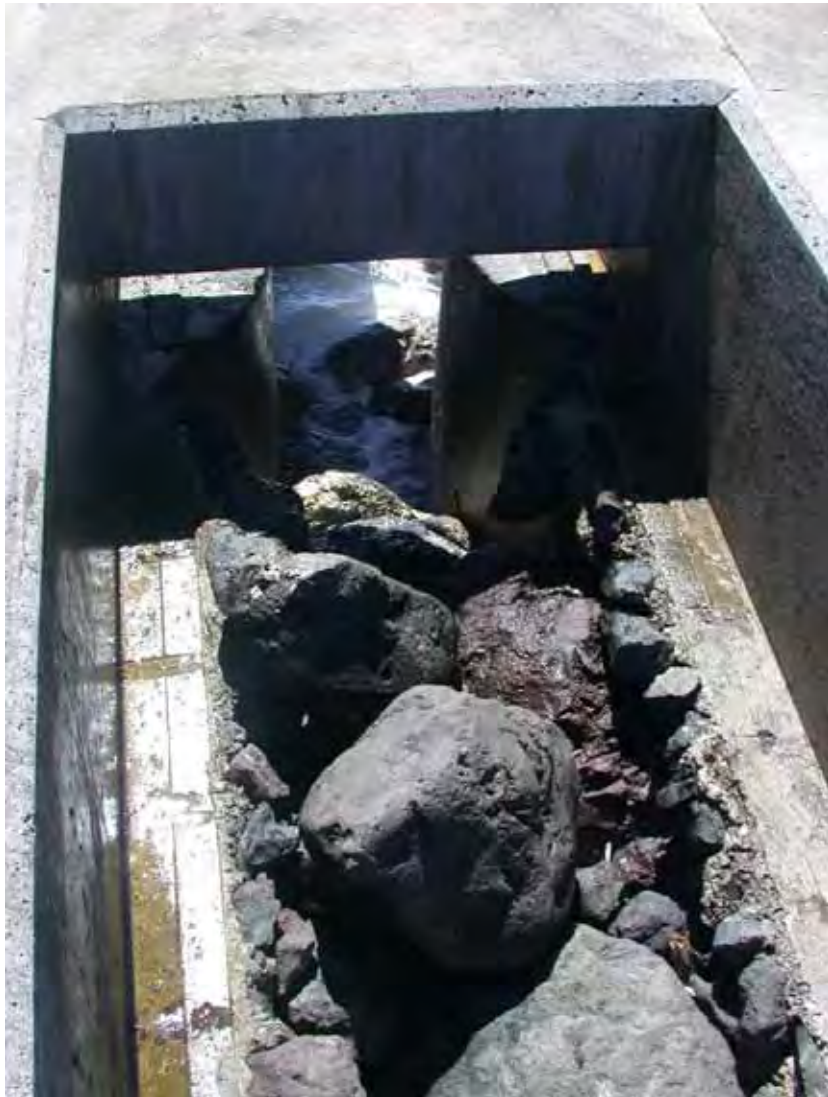
Figure C10. Underlayer loss and shifting of stones between ribs.

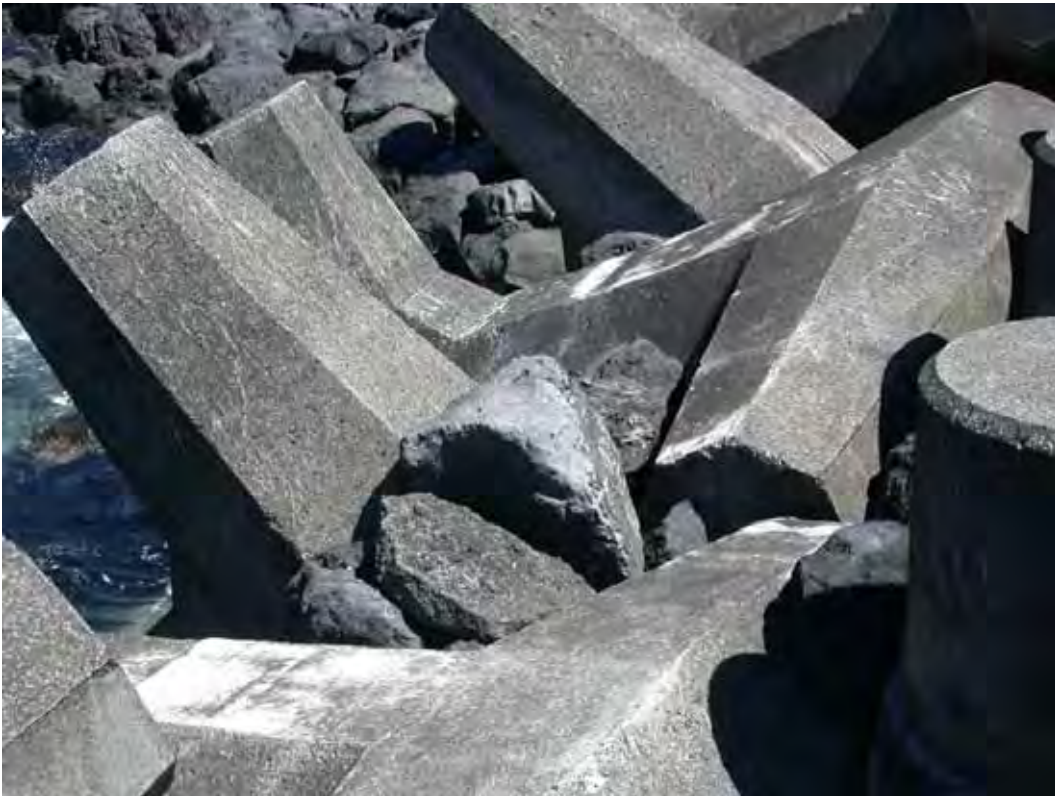
Figure C11. Displaced armor stone, tossed onto dolosse.

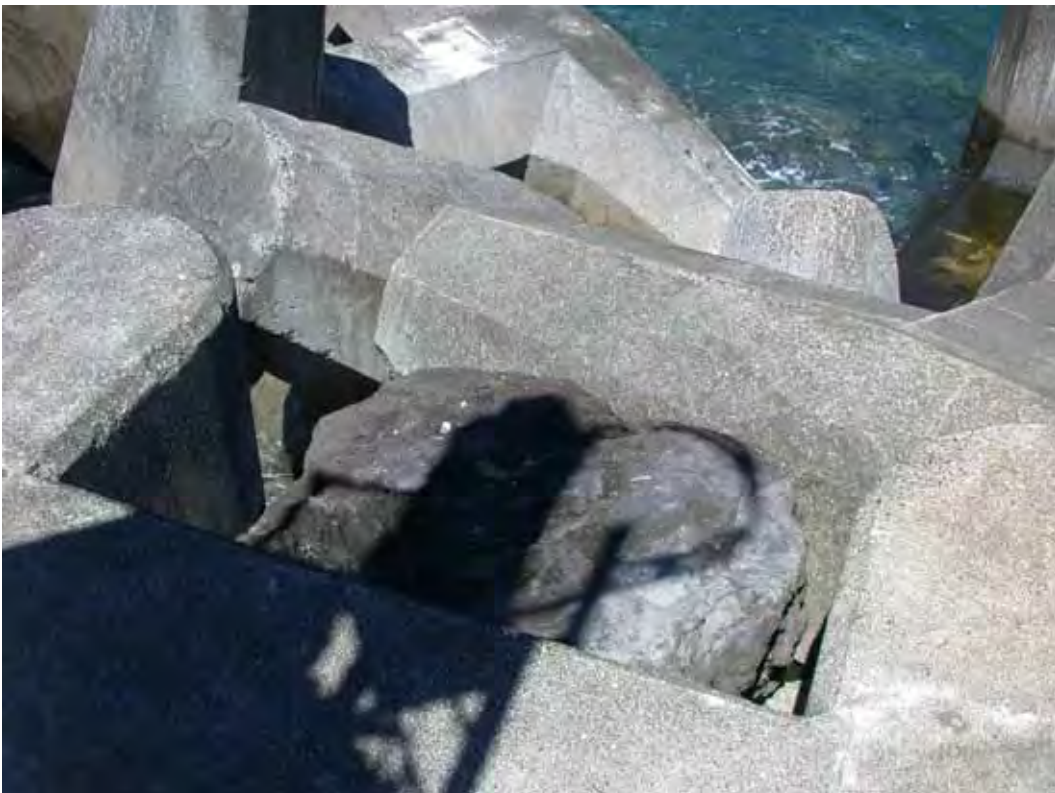
Figure C12. Displaced armor stone, tossed onto dolosse.

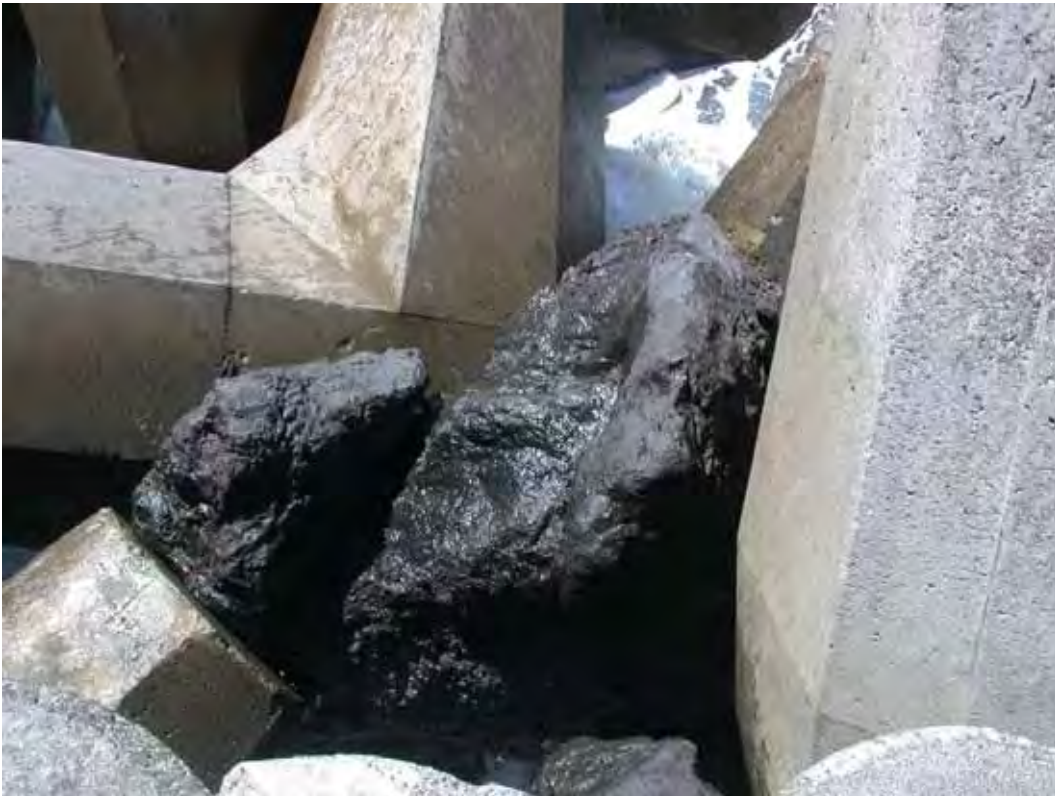
Figure C13. Displaced armor stone, tossed onto dolos.
